Sample Repair Shop  
Preliminary Estimate

Type of Loss: Collision

2017 FIAT 500 Lounge Cabriolet

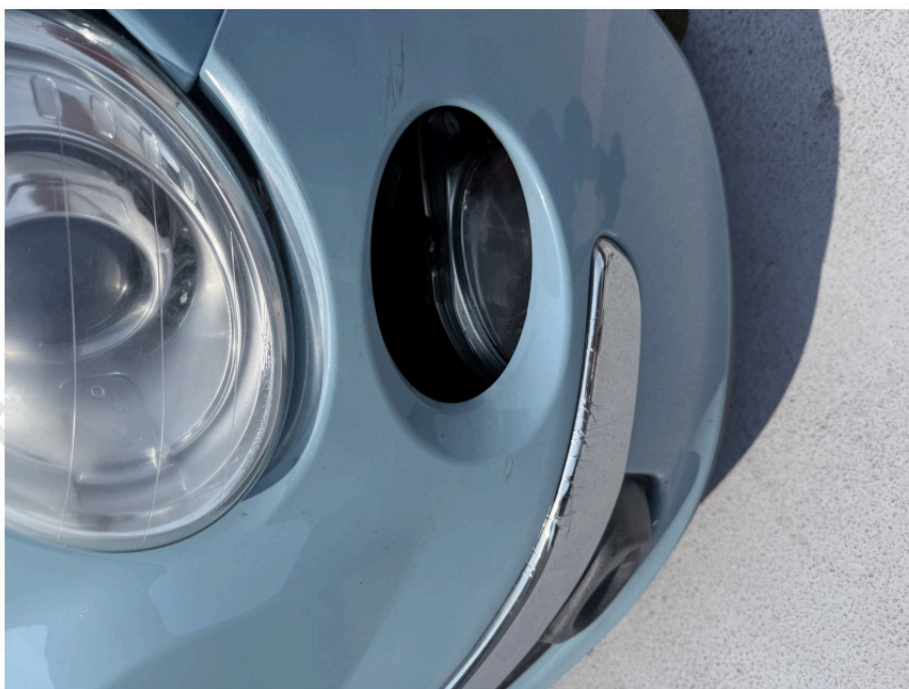
Front Bumper - 0 dents (verified)

| Line | Sym | Oper | Description | Part Number | Qty | Extended Price \$ | Labor | Paint |
|---|---|---|---|---|---|---|---|---|
| 8 | | Rpr | Repair Front Bumper | | | | 2.5 | |
| 9 | | Refn | Refinish - Front Bumper | | | | | 2.5 |

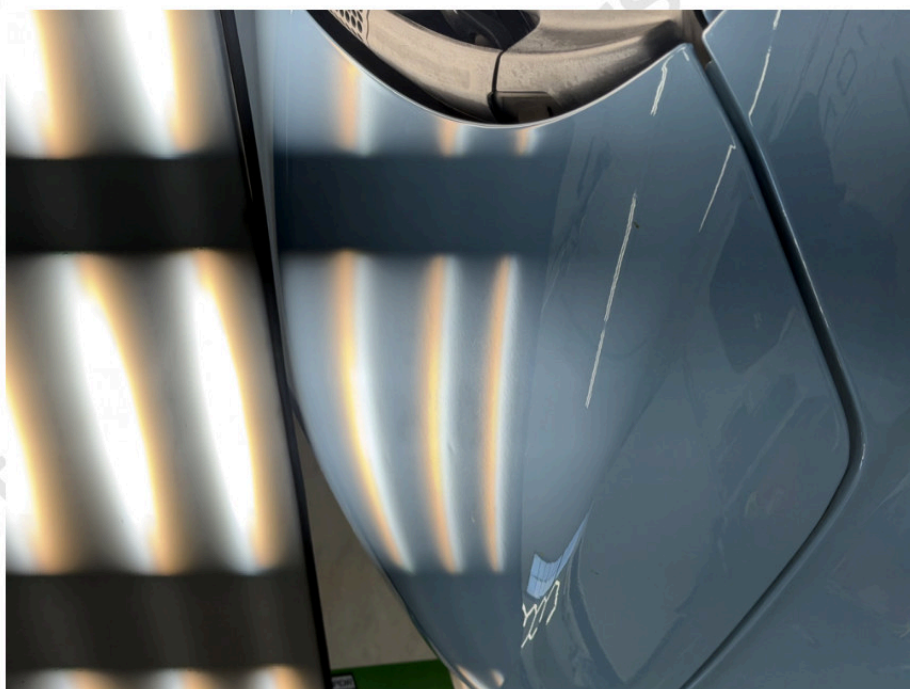
Hood - 0 dents (verified)

| 39 | | Blnd | Blend - Hood | | | | 1.5 |

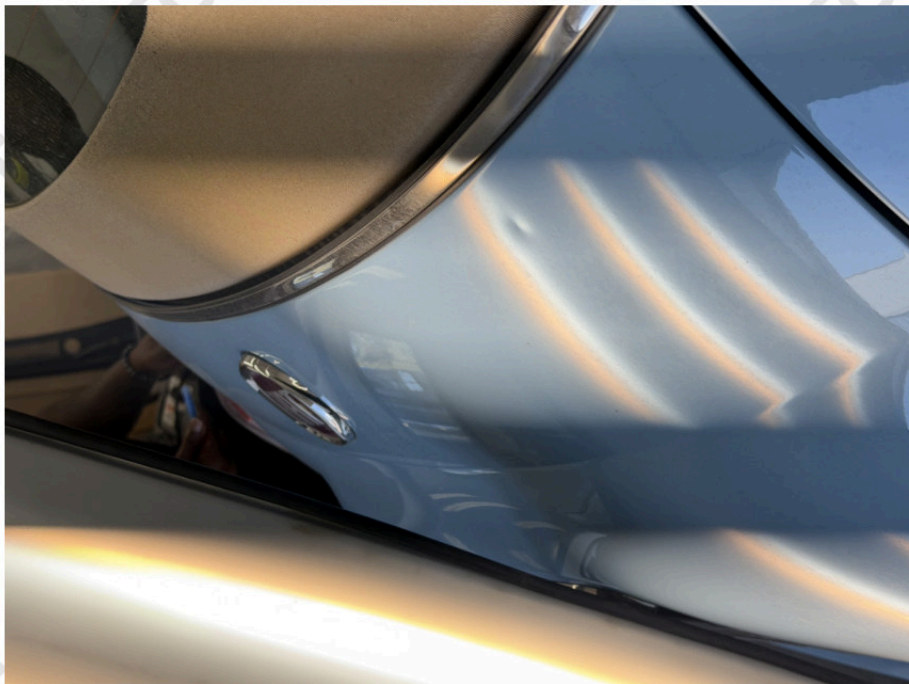
Trunk - 0 dents (verified)

| 37 | | Rpr | Repair Trunk | | | 1.5 | |

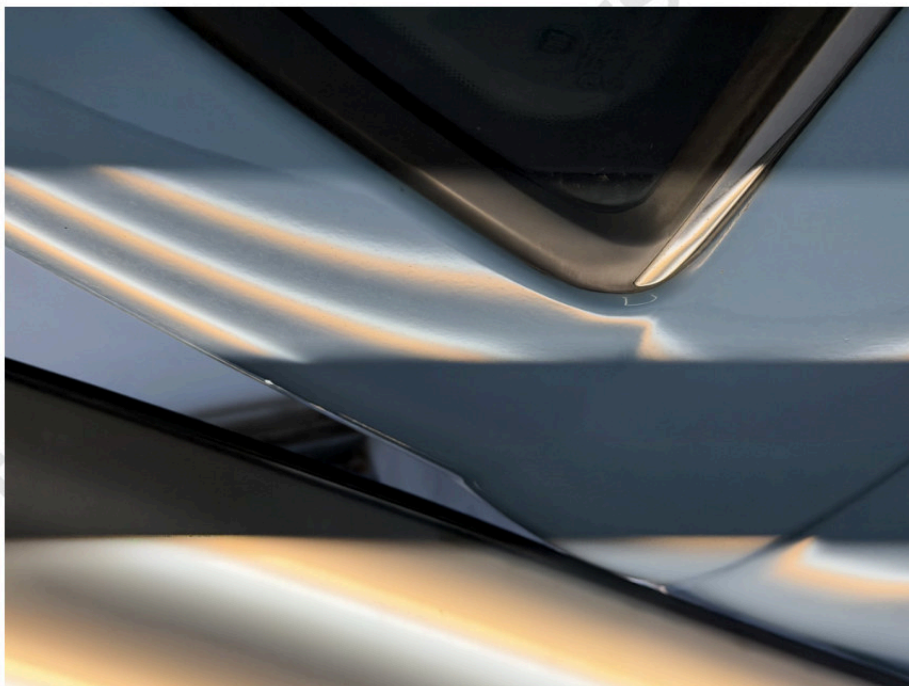
| 27 | # | Rpr | Possible frame/structural involvement at Quarter Right - refer for frame inspection | | | | |

Quarter Right - 0 dents (verified)

| 22 | | Rpr | Repair Quarter Right | | | 3.5 | |
| 23 | | Refn | Refinish - Quarter Right | | | | 3 |

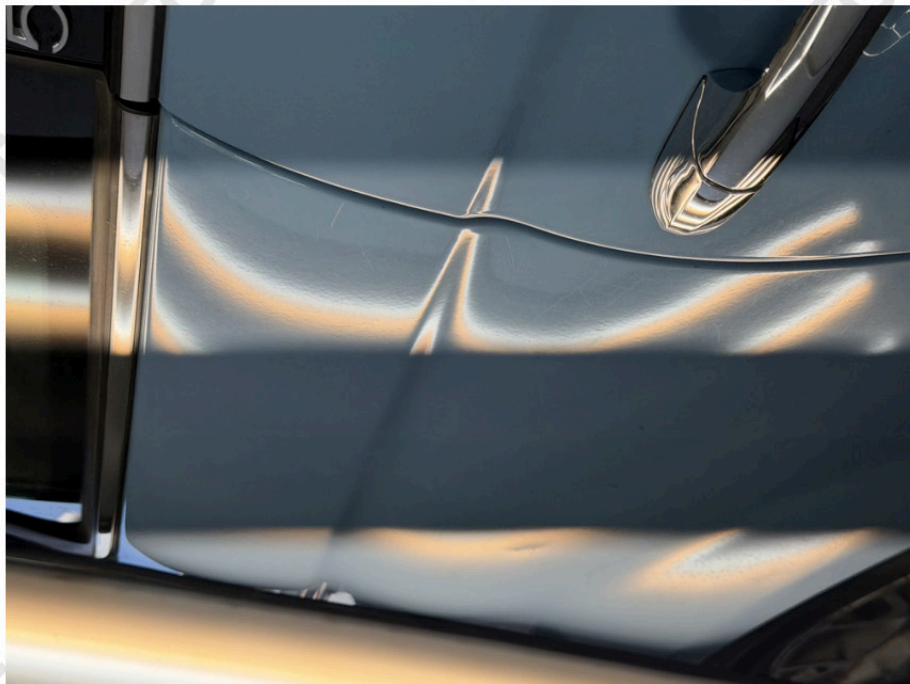
Rear Door Right - 0 dents (verified)

| 29 | | Rpr | Repair Rear Door Right | | | 3.5 | |
| 30 | | Refn | Refinish - Rear Door Right | | | | 2.5 |

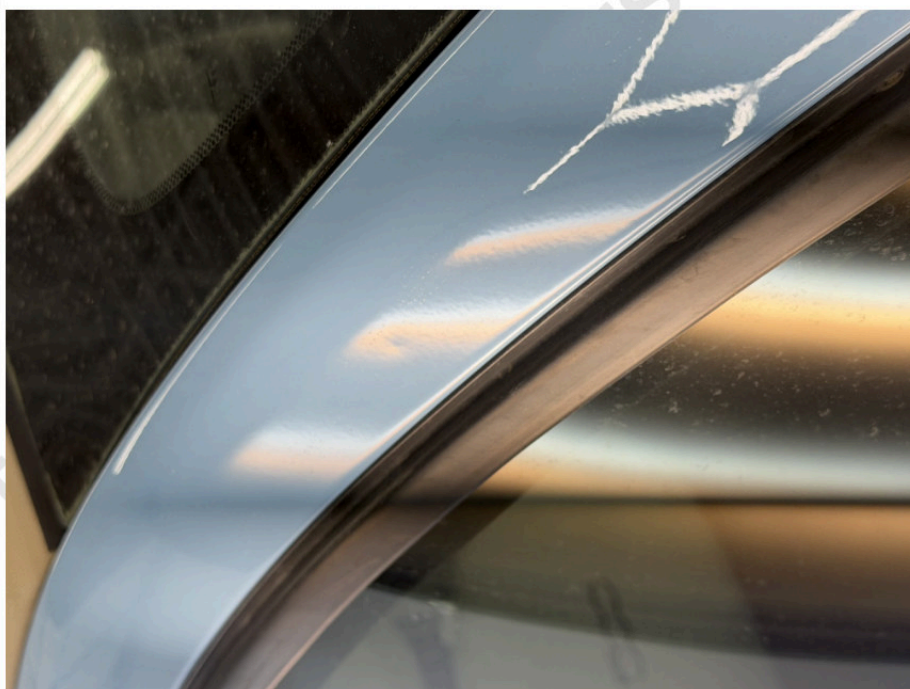
Rear Door Left - 0 dents (verified)

| 45 | | Blnd | Blend - Rear Door Left | | | | 1.2 |

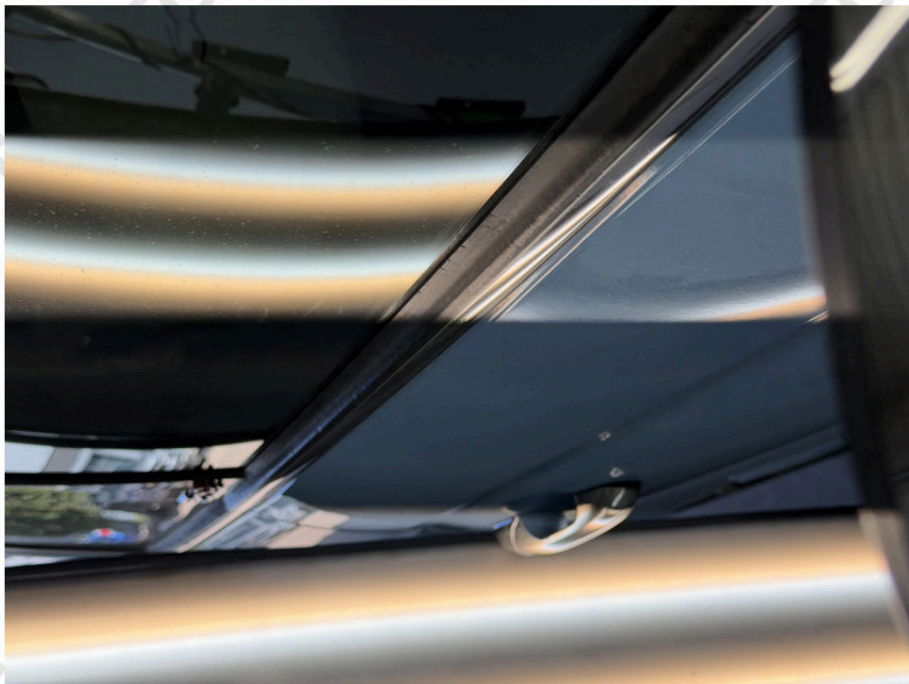
Front Door Right - 0 dents (verified)

| Line | Sym | Oper | Description | Part Number | Qty | Extended Price \$ | Labor | Paint |
|---|---|---|---|---|---|---|---|---|
| 14 | | Rpr | Repair Front Door Right | | | | 1.5 | |

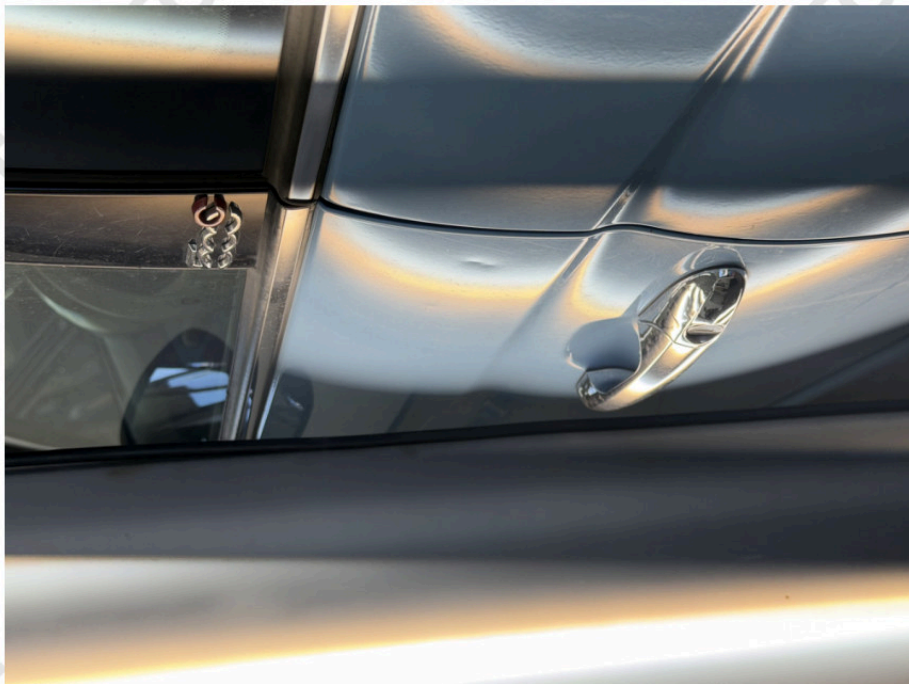
Front Door Left - 0 dents (verified)

| 42 | | Blnd | Blend - Front Door Left | | | | 1.2 |

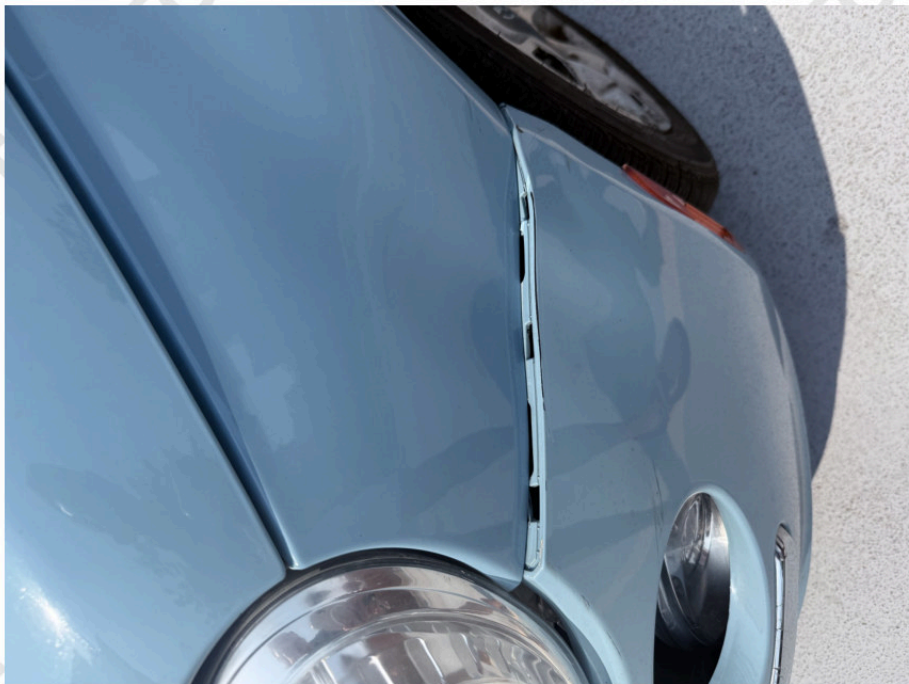
Fender Left - 0 dents (verified)

| Line | Sym | Oper | Description | Part Number | Qty | Extended Price \$ | Labor | Paint |
|---|---|---|---|---|---|---|---|---|
| 2 | | Rpr | Repair Fender Left | | | | 2.5 | |
| 3 | | Refn | Refinish - Fender Left | | | | | 2 |
